GRIMWADE PINE PLANTATION FIRE

(KIRUP 19)

REPORT BY PROTECTION BRANCH (FIRE), S.H.Q. COMO - MAY 1984

GRIMWADE PINE PLANTATION FIRE (KIRUP 19) - 2 MARCH 1984

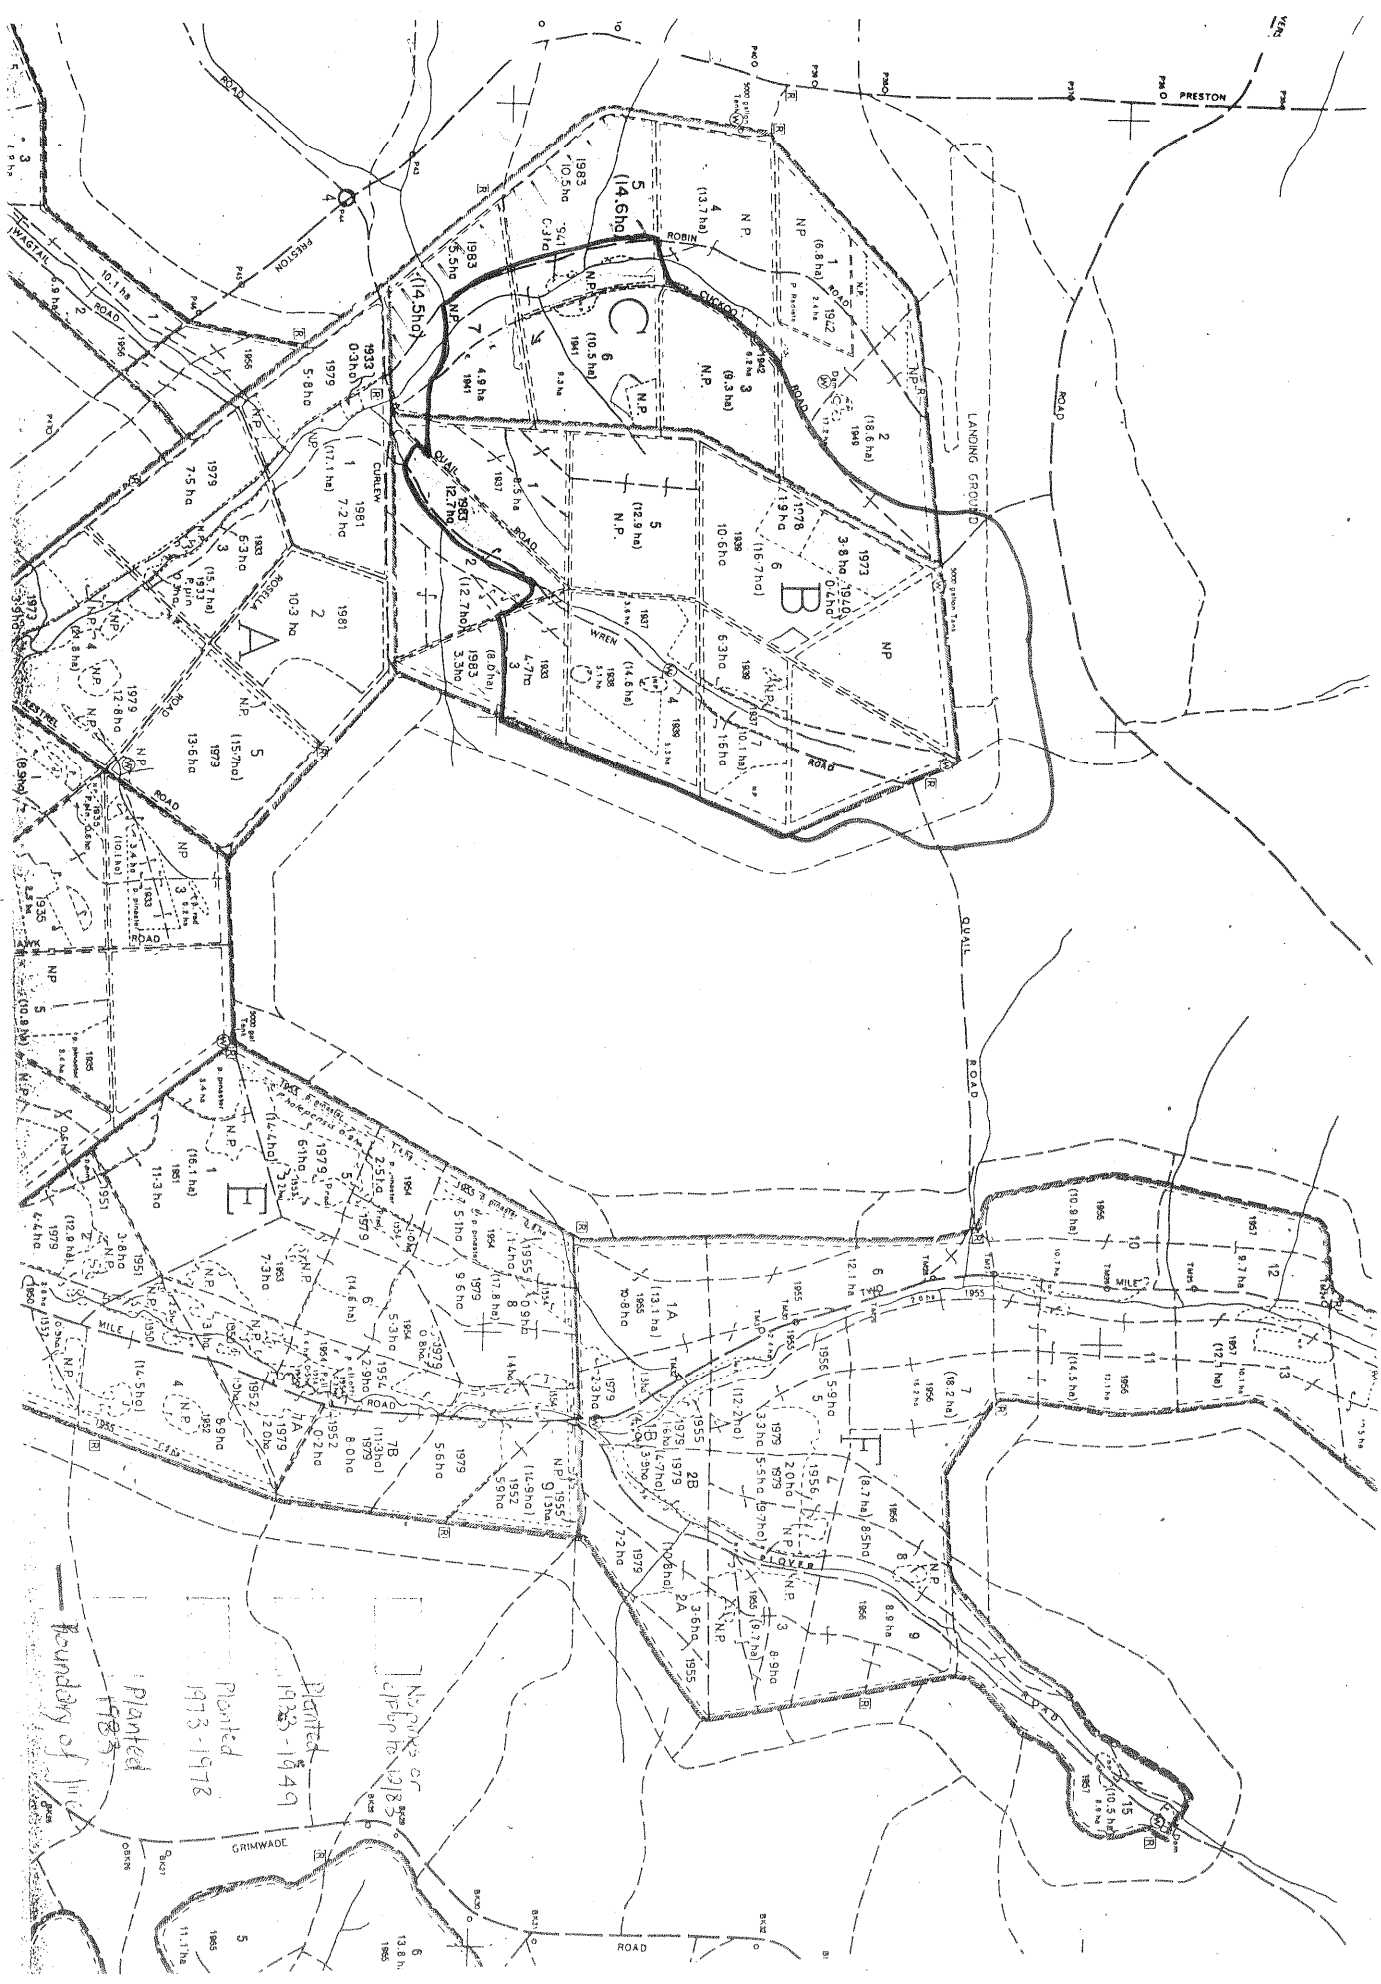
Grimwade Fire of 2.3.84

Detected at 14:30 hrs.
